Manhole Inspection Summary

Manhole # S05SS1006MH

Location Address: **5424 CLOVER RD**

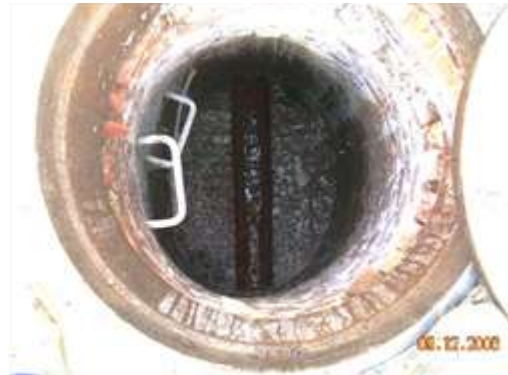
Top View

Frame leaks. Frame offset. Bench and Channel debris.

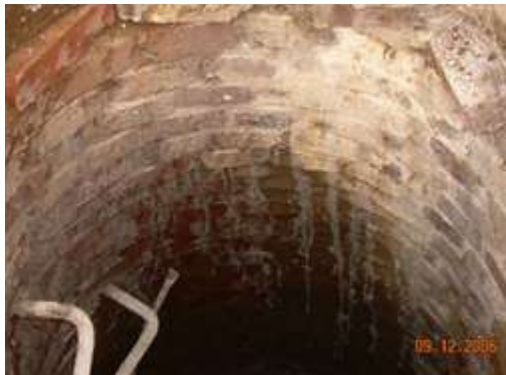
Defect

Frame leaks. Adjustment deterioration, loose brick, and infiltration. Barrel infiltration.

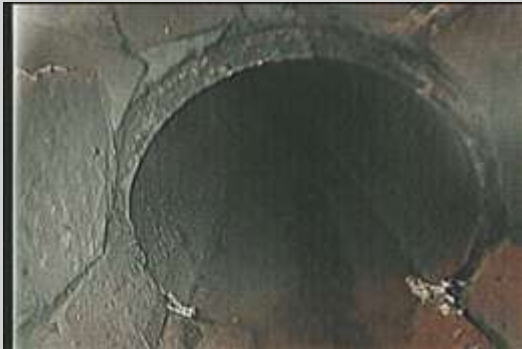
8 in. Circular Gravity Sewer Pipe Out @ 12 O'Clock

Infiltration: **Evidence** Pipe Seal Cond: **Cracked**

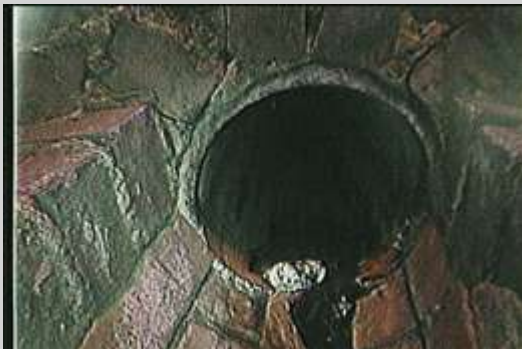
8 in. Circular Gravity Sewer Pipe In @ 6 O'Clock

Deposits: ☐ None ☐ Mud ☐ Sludge ☒ **Debris** ☐ Grease

Silt Depth: **0** (in.) Deposits Extent: **Light**

Infiltration: **Evidence** Pipe Seal Cond: **Cracked**
